“QualificaURB” tool: analysis of the socio-environmental quality of renovated urban squares

CADERNOS DE PÓS-GRADUAÇÃO EM ARQUITETURA E URBANISMO

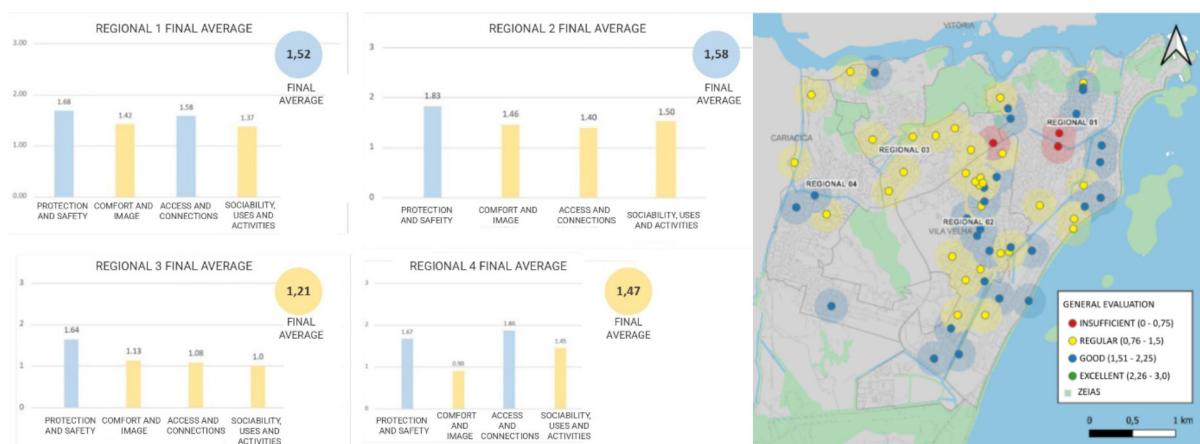
Figure 2: On the left, charts of the four Regions with the classifications and scores, by category, of the evaluated squares. On the right, the spatial distribution of the squares with their respective socio-environmental quality results.

The results were spatialized after applying the "QualificaURB" tool to the renovated squares, highlighting the general evaluations of the squares and the performance by category (Figure 2). Out of the analyzed squares, 5% were classified as "insufficient," while 95% received classifications of "fair" and "good," reflecting an intermediate socio-environmental quality scenario. It should be emphasized that none of the analyzed squares reached the classification of "excellent."

When observing the spatial distribution of the squares and their respective classifications, it becomes clear that Regionals 1 and 2, which have better infrastructure conditions and a larger number of planned neighborhoods, also concentrate the highest number of squares classified as "good" (represented in blue in Figure 2). In Regional 1, for instance, 9 squares were requalified, contributing to 14 of the 22 existing squares being classified as "good," which corresponds to more than 60% of the total in Regional 1.

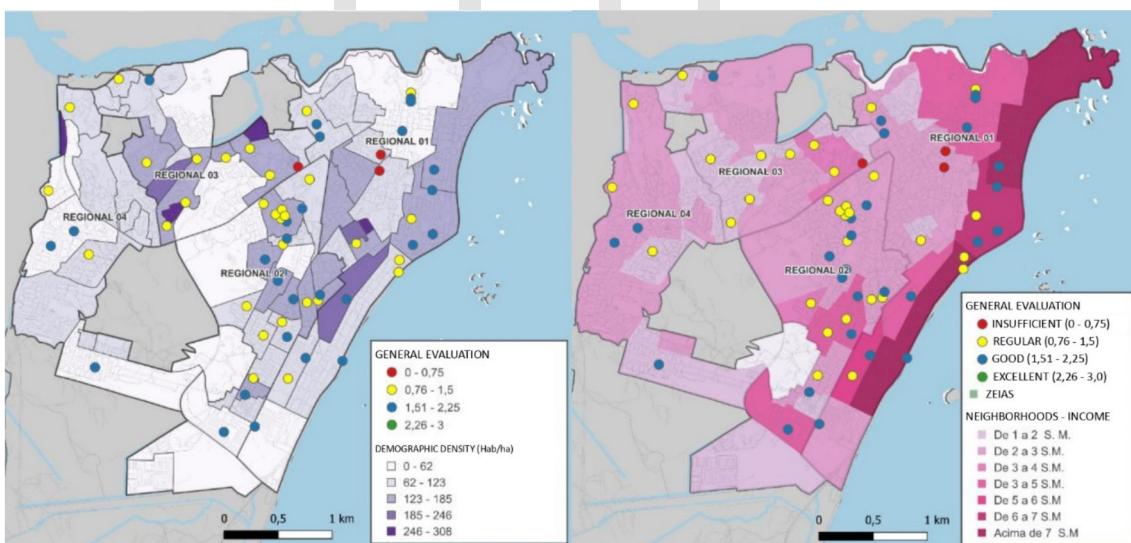
Figure 3: On the left, a map presenting the overall evaluations of the socio-environmental quality of the squares in relation to population density (inhabitants/ha). On the right, a map showing the overall evaluations of the socio-environmental quality of the squares in relation to per capita income (minimum wage).

The maps presented in Figure 3 correlate the squares' socio-environmental quality assessment with their neighborhoods' socioeconomic conditions, considering demographic density data (inhabitants/ha) and per capita income, based on IBGE Census data (2010). It is observed, therefore, that there is a greater concentration

of squares with better evaluations ("Good" and "Fair") in coastal neighborhoods with high per capita income and in squares located in planned and traditional communities of the city. Conversely, squares classified as "insufficient" are predominantly located in low-income neighborhoods with high demographic density.

The maps in Figure 3 also highlight an unequal distribution of squares in quantity and quality. Regional 3, for example, where neighborhoods with the highest demographic densities in the municipality are concentrated, has only 10 squares distributed among its 18 neighborhoods. Among these, only one was evaluated as "good," while the others received classifications of "fair" or "insufficient." This scenario reinforces the urgency of investments in public spaces, especially in the squares of Regional 3, both for the creation of new ones and for the requalification of existing ones.

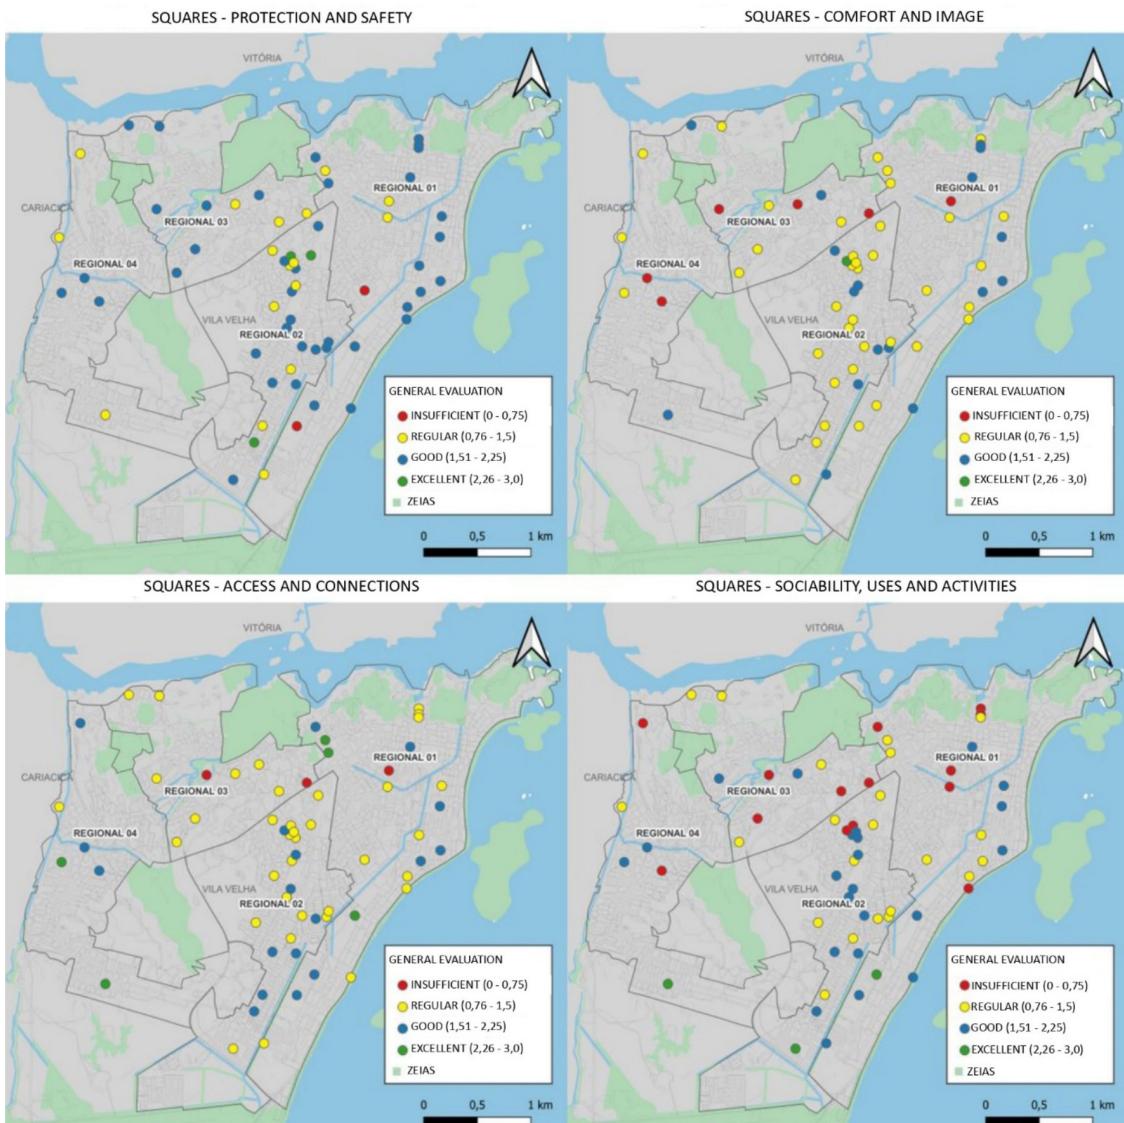
Figure 4: Spatial distribution of the squares, by classification category in the socio-environmental quality assessment.

The analysis of the results, spatialized in the maps in Figure 4, became a fundamental step in understanding specific factors that influenced the evaluations of the squares. This approach made it possible to identify, through the indicators, the elements responsible for the assigned scores, offering a more detailed and strategic perspective to guide future interventions.

When analyzing the averages by region, the category "Protection and Safety" stands out for presenting the best performance in almost all Regionals. Meanwhile, the category "Comfort and Image" registered the lowest averages across all regionals. These data highlight both weaknesses and potentialities of

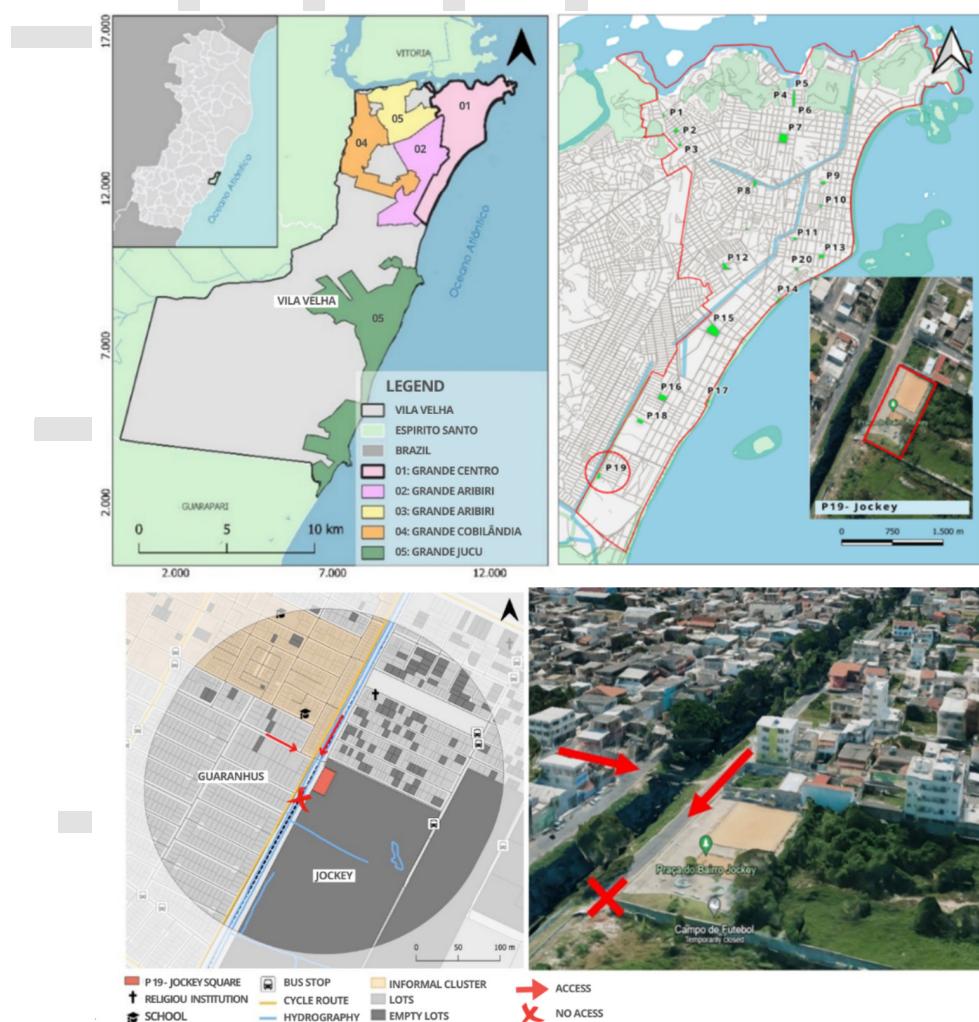
Figure 5: Location and aerial view of Jockey Square and its surroundings.

Jockey Square, selected as the case study in this article, is in Regional 01—Grande Centro, in the Jockey de Itaparica neighborhood (Figure 5). It has an estimated population density of 19.70 inhabitants/ha and an average per capita income of 2 to 3 Brazilian minimum wages (IBGE, 2010). However, it is a neighborhood undergoing expansion, with recent activity from the real estate market.

With an area of approximately 2,000 m² and a rectangular layout, the square is located on a block corner, with three of its four façades bordered by walls (Figure 5). This configuration limits access and connections with the square, obstructing the visual field and contributing to a greater sense of insecurity in the area. Single-family housing predominates in the square's surroundings, without community facilities (Figure 5). It is also worth noting that the square is located at the boundary with the Guaranhuns neighborhood, near vacant urban land and an area characterized by informal settlements.

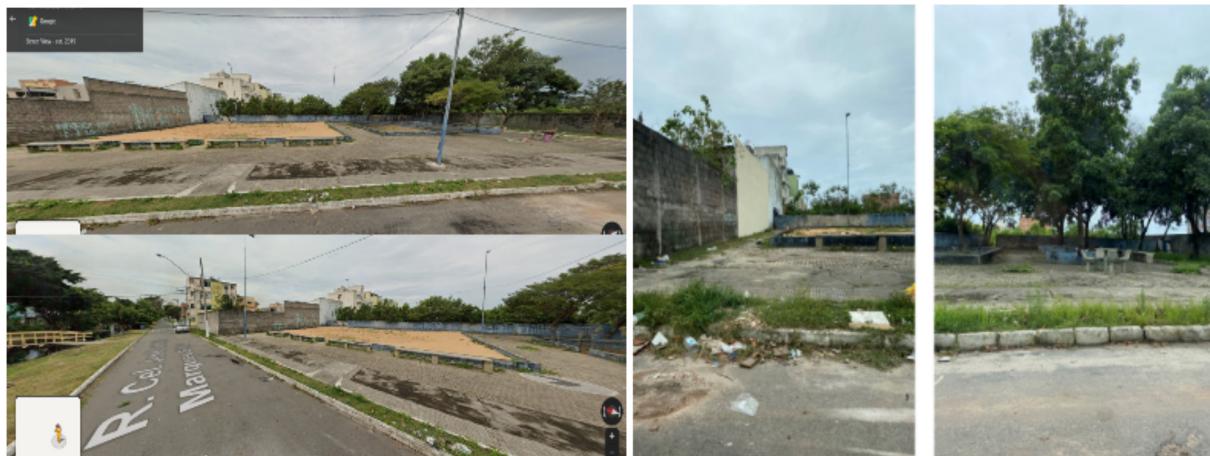
Figure 6. Images of Jockey Square before the renovation.

When the "QualificaURB" tool was applied before the renovation, Jockey Square received an "insufficient" rating (score 0.43). Characterized by the absence of facilities, furnishings, and aesthetic quality, the square offered minimal lighting, public safety infrastructure, and a lack of accessibility, landscaping, and seating areas, resulting in low pedestrian flow during both day and night (Figure 6). These aspects defined the square as an abandoned space, compromising the safety of residents.

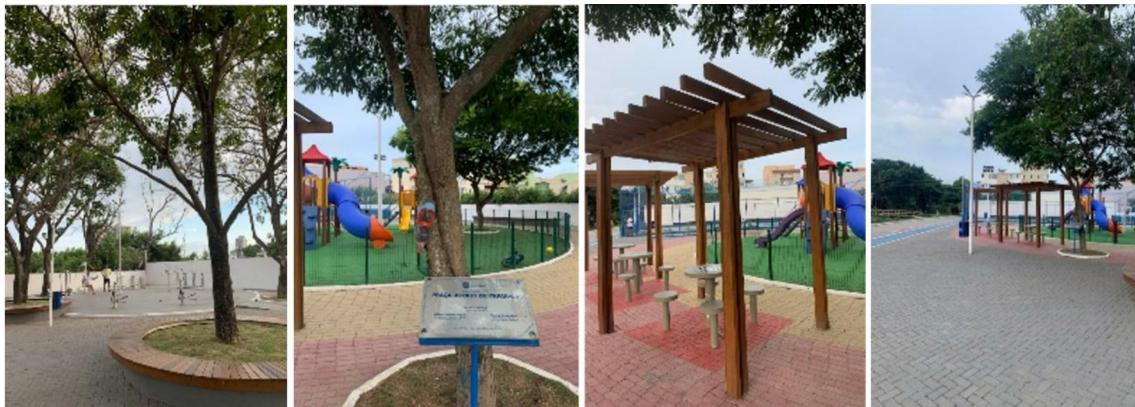
Figure 7: Images of Jockey Square after the renovation.

Regarding the "**Comfort and Image**" category, before the renovation, Jockey Square was rated as "Regular" (score 1.08), a situation reflected in the space by the absence of landscaping, aesthetic quality, seating, shaded areas, and adequate waste collection. These characteristics also contributed to insecurity in the square, which affected the entire neighborhood. Following the intervention, new garden beds, wooden and concrete benches, ramps to address level changes, and pergolas over the chess tables were added (Figure 7).

These elements resulted in a "Good" rating (score 2.24) for the "Comfort and Image" category, representing a considerable improvement compared to the previous "Regular" rating (score 1.08). It is worth noting that in the "Shade and Vegetation" indicator, the square did not reach satisfactory conditions; however, it presents a level comparable to other squares in the city, which are generally arid, heavily paved spaces lacking greenery.

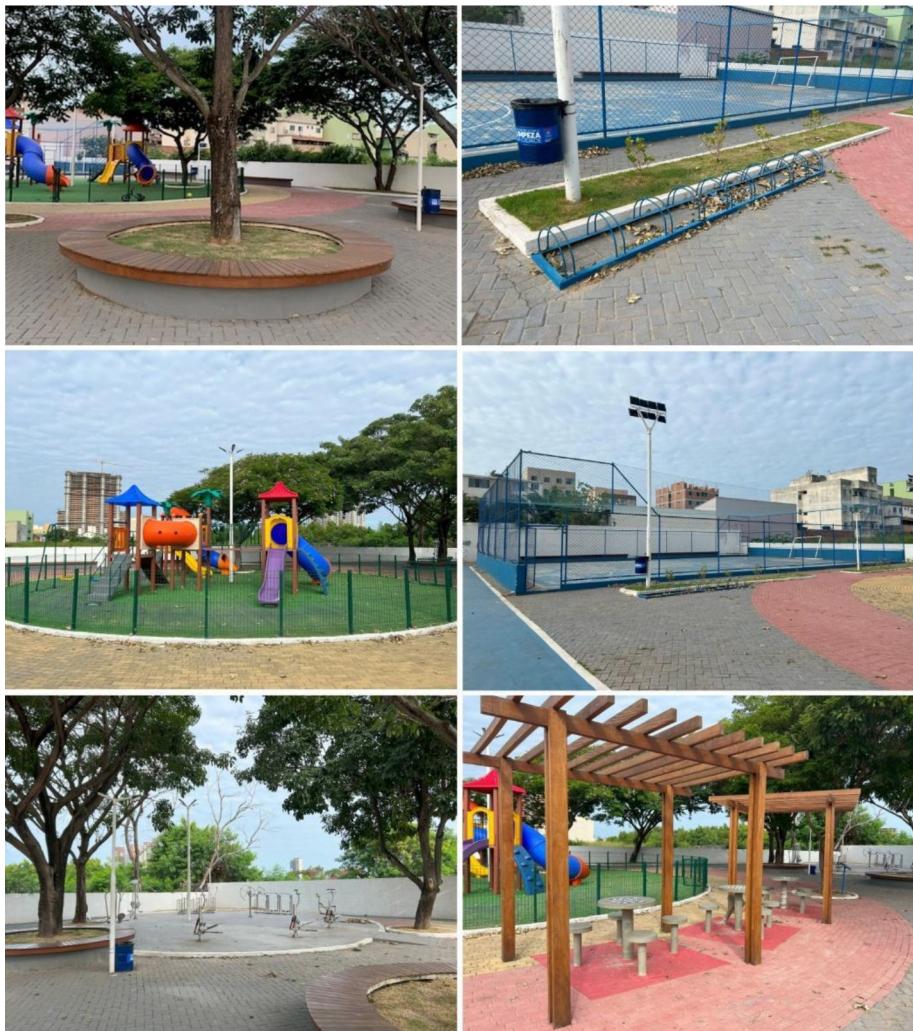
Figure 8: Jockey Square after renovation. The images show the new paving, benches in the garden beds, the bicycle rack installed near the sports court, the rotomolded plastic playground, the outdoor gym in stainless steel, the sports court, and the chess tables under pergolas.

In the "Access and Connections" category, there was also an improvement from an "Insufficient" rating (score 0.25) to "Regular" (score 1.33). The renovation added new paving, adjusted pathways to a width suitable for comfortable pedestrian circulation, and installed bicycle racks to facilitate bicycle use. Although well laid, the new interlocking concrete block paving has wide joints, limiting full accessibility of the area (Figure 8). The square still lacks connectivity, mainly due to its isolated location within the neighborhood, which hinders connections with the surrounding community.

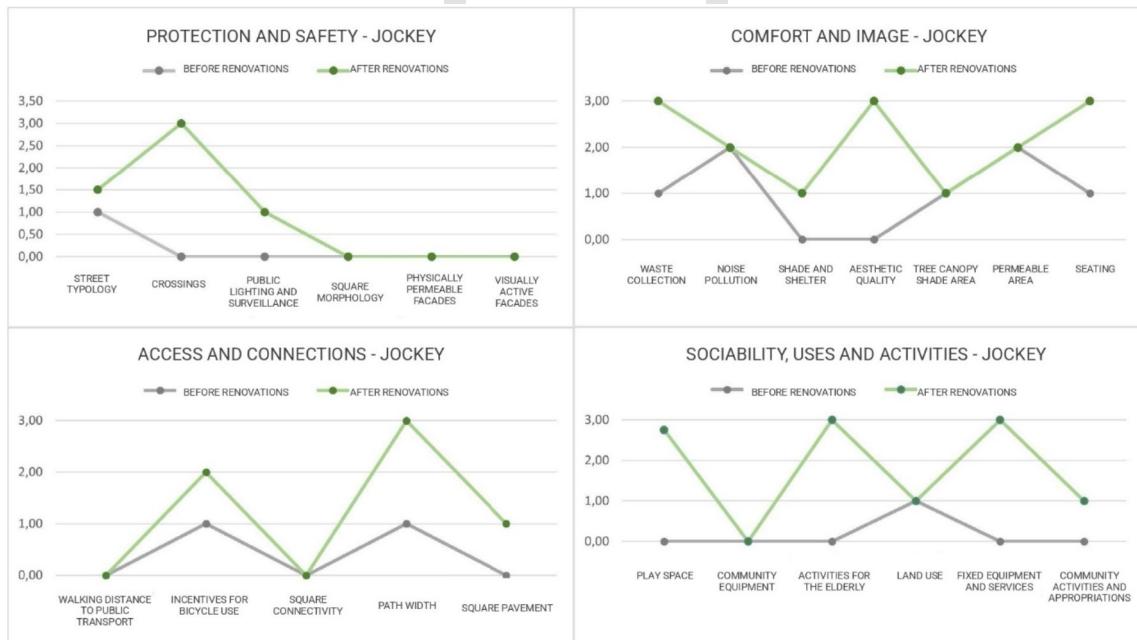
Figure 9: Graphs of the overall evaluation results of Jockey square using the "QualificaURB" tool, divided by category and their specific indicators.

The results of the indicators for each category of the "QualificaURB" tool are illustrated in the charts in Figure 9, where the performance of each indicator is compared before and after the renovation. Indicators that showed no improvement are primarily associated with the characteristics of the square's surroundings, where no interventions occurred, such as morphology, land use, façade typology,

connectivity of access points, and the presence of community facilities. The lack of interventions in the surrounding area also highlights structural limitations in municipal urban planning, characterized by a lack of coordination between responsible sectors and the population, and weaknesses in the Master Plan.
